Manhole Inspection Summary

Manhole # S49A__010MH

Location Address: **2518 Jefferson**

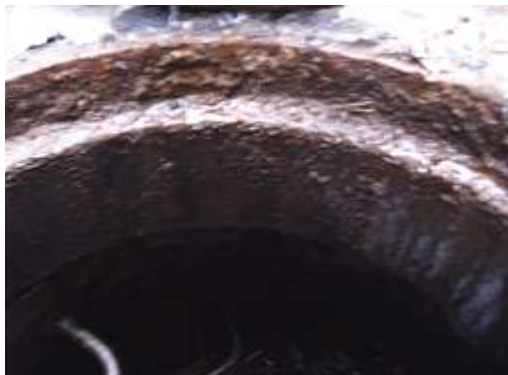
Defect 2

☒ **Leaks**

frame

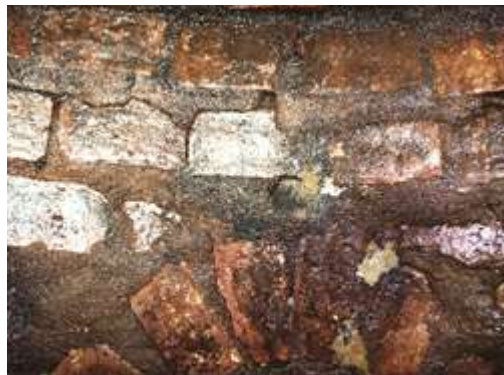
Defect 1

infiltration
